Saving time, money and lives

Marian meets stringent building codes and criteria

PROJECT	Marian Regional Medical Center – Santa Maria, California
OWNER	Dignity Health – San Francisco, California
ARCHITECT OF RECORD	Moon Mayoras Architects, Inc. – San Diego, California
INTERIOR DESIGNER	Brandt Design Group Inc., Valley Center, California
CONSTRUCTION MANAGER	Kitchell, San Diego, California
INSTALLING CONTRACTOR	Martin Integrated, Orange, California
ROCKFON PRODUCTS	Chicago Metallic 1200 Seismic Suspension 15/16-inch Suspension System with 1496 Seismic Perimeter Clip

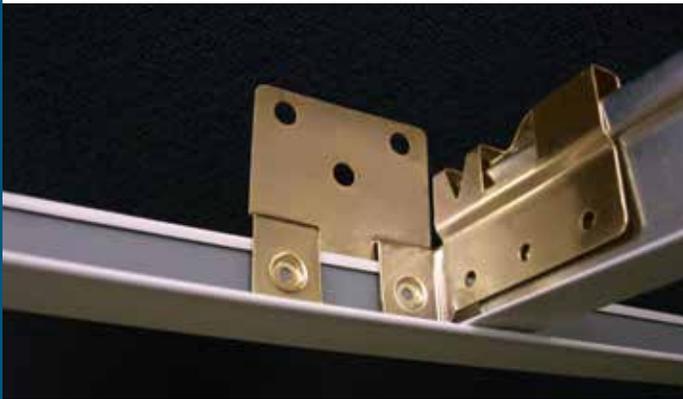
1496 Seismic Perimeter Clip meets the ICC seismic criteria.

system. What you won't see is the 1496 Seismic Perimeter Clip. This essential component works behind the scenes to meet the International Code Council seismic performance requirements and to provide a clean, sleek look."

As an approved alternative construction method for all Seismic Design Categories (SDCs), the 1496 Seismic Perimeter Clip attaches

to a wall angle, main runner and cross-tees that support ceiling tiles. For the SDC D associated with Marian Regional Medical Center, the use of the International Code Council Evaluation Service (ICC_ES) recognized, seismic perimeter clip may replace the 2-inch wall angle with a 15/16-inch wall angle and eliminate the need for spacer bars.

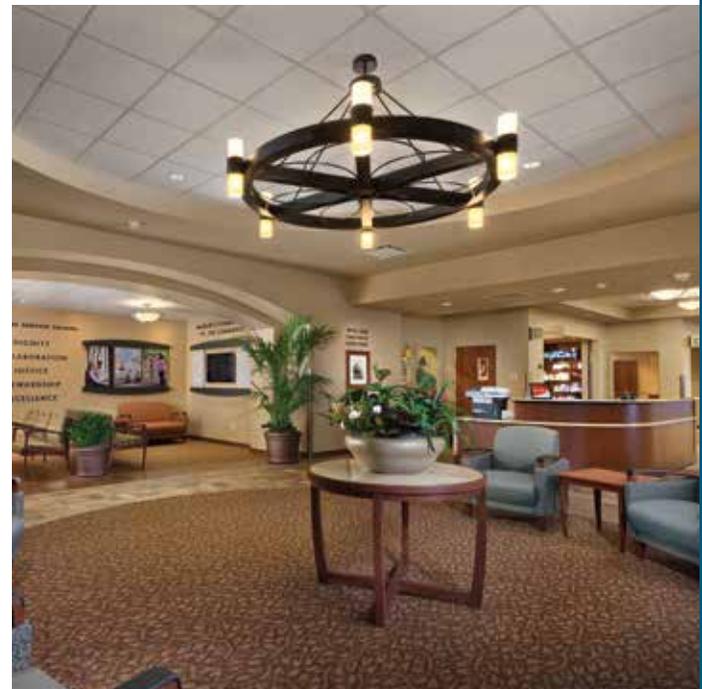
The 1496 Seismic Perimeter Clip and 1200 Seismic ceiling suspension system offers a clean appearance with complex performance.

"As a design element, the ceiling system is rather minimalist in appearance, but it's complex in its performance," observes Prukop. He elaborates, "Our Chicago Metallic 15/16-inch 1200 Seismic ceiling suspension systems are the industry standard for suspended ceilings. For Marian, this Heavy-Duty suspension system is used throughout the building. Everywhere you look, you'll see our ceiling suspension

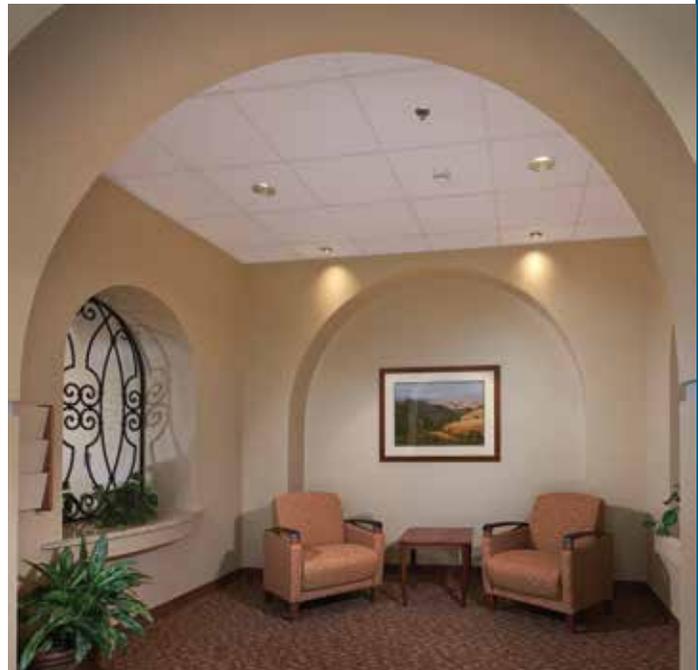
OSHPD approves 1496 Seismic Perimeter Clip as alternative construction method.

The authority having jurisdiction or onsite inspector is responsible for the interpretation and enforcement of the building code at a local level. For Marian Regional Medical Center, inspections were stringent and thorough. Aiding in this effort, ROCKFON manufactures its Chicago Metallic 1496 Seismic Perimeter Clip in an electro-deposited, gold-color finish to make them easily visible to the inspectors.

In Spring 2011, Marian Regional Medical Center's building team received OSHPD approval for the Chicago Metallic 1496 Seismic Perimeter Clip. Martin Integrated started installing immediately after having the signed papers in hand.
